# OWNER'S INSPECTION CHECKLIST

**DAM NAME:** Oktibbeha County Lake Dam

**DAM INVENTORY NO:** MS00338  
**HAZARD CLASS:** High

**DATE OF INSPECTION:** Inspection completed on June 18, 2024. All photos included were taken during this site visit.

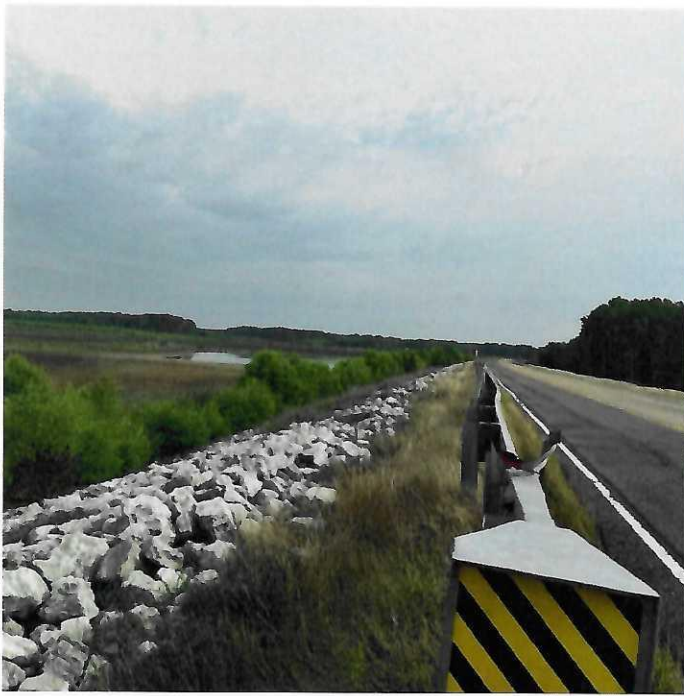
Some areas of the US Face have steep slopes and sparse rip rap. Thicker brush on north end. Tree saplings should be removed.

PHOTO 1—Upstream slope view from right side of dam

Seemed to be potential for erosion.  
Additional rip-rap should be placed on slope. Saplings should be removed.

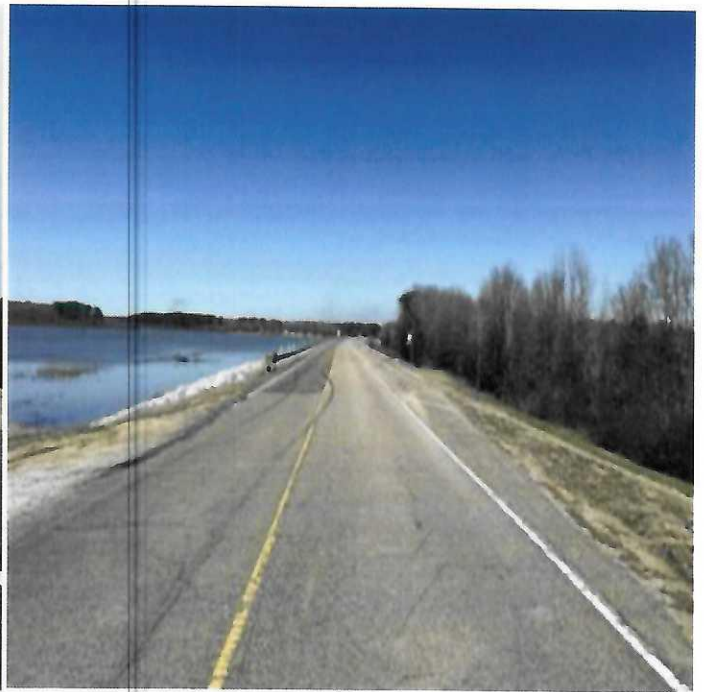
PHOTO 2—Dam crest view from right side of dam

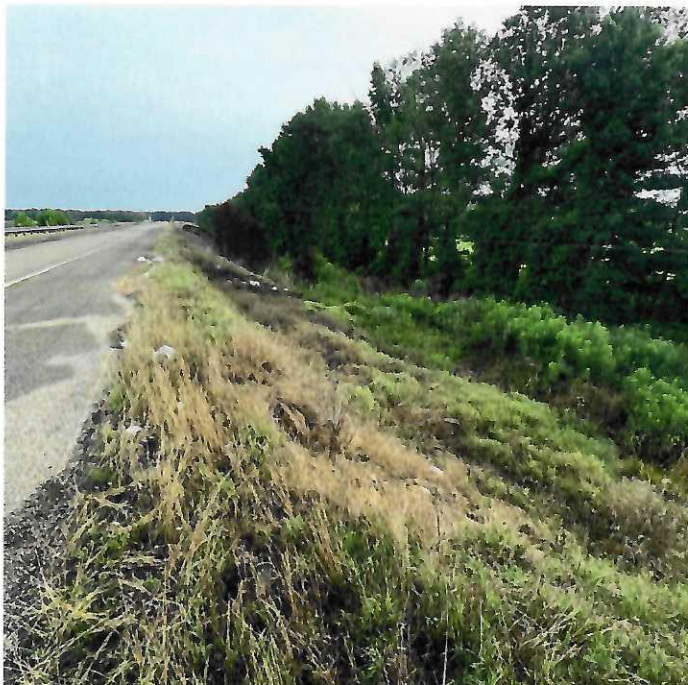
Significant erosion and slides observed right of primary spillway for several hundred feet. Slope is approximately 1.5:1 which is too steep for stability.

PHOTO 3 —Downstream slope view from right side of dam

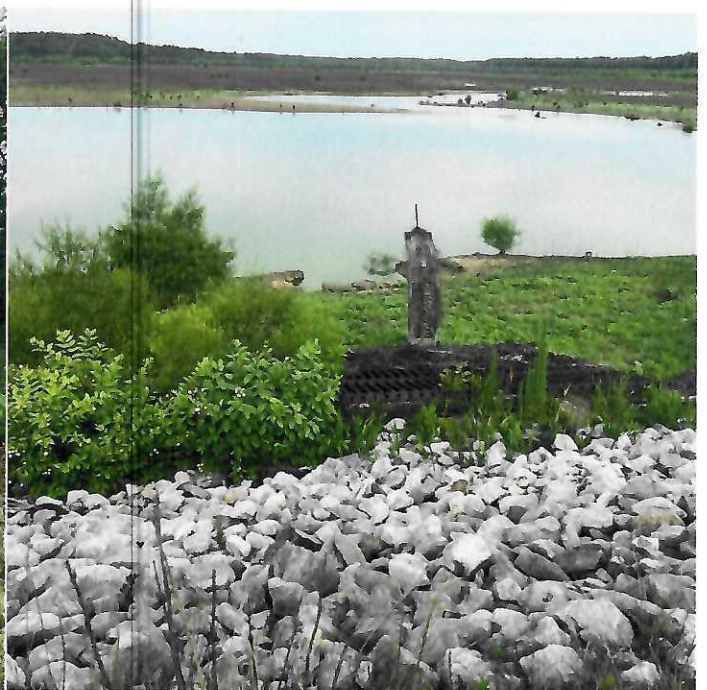
Spalling, cracking, and scaling occurring. Exposed reinforcement. Corrosion present. Inlet obstructed. Primary spillway has been removed, thus removing permanent pool.

PHOTO 4—Primary spillway (note missing riser)

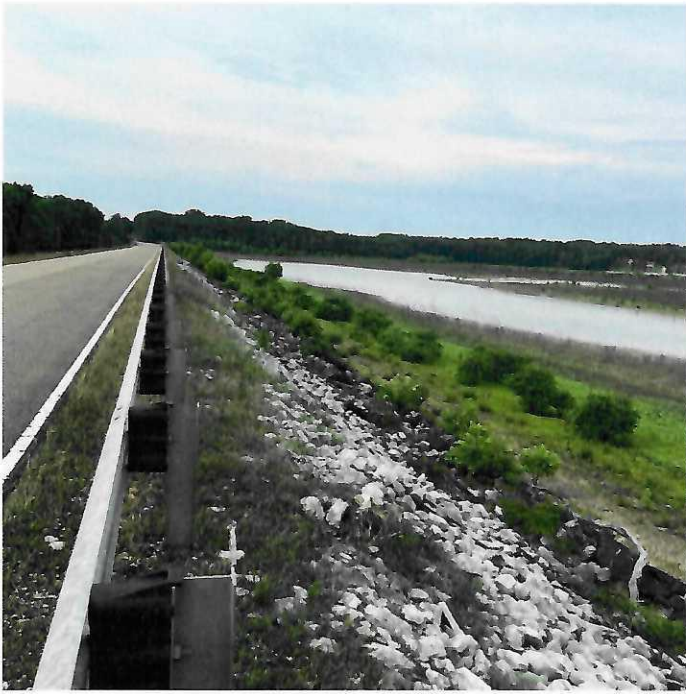
PHOTO 5—Upstream slope view from left side of dam

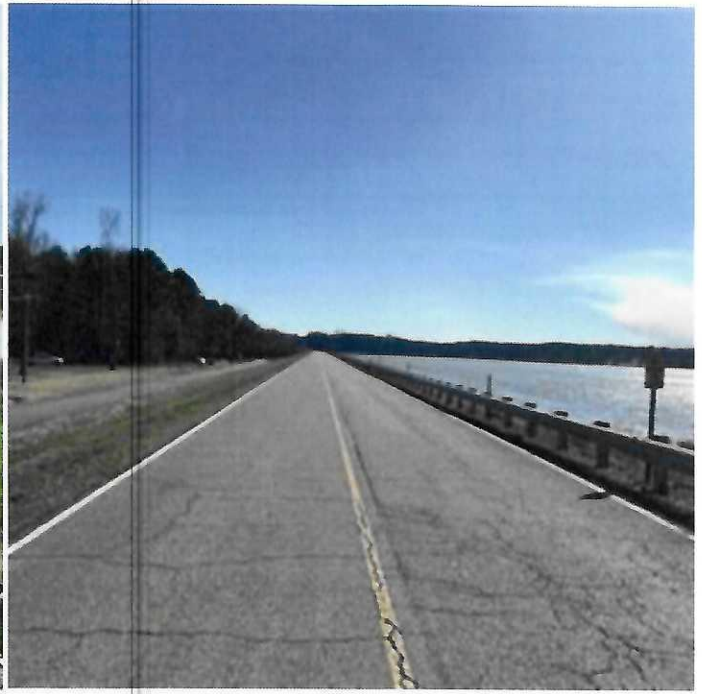
PHOTO 6—Dam crest view from left side of dam

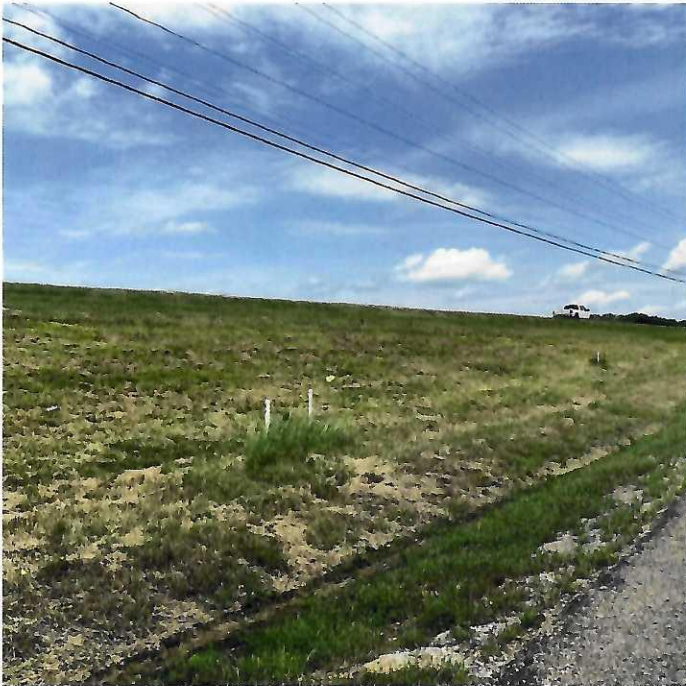
There are five (5) two-inch diameter open standpipe piezometers located adjacent to the downstream slope of the dam, along the west side of Perkins Road. The piezometers are not being monitored because of the lake has no permanent pool.

PHOTO 7 —Downstream slope view from left side of dam  
(Utility lines visible and 3 of 5 piezometers)

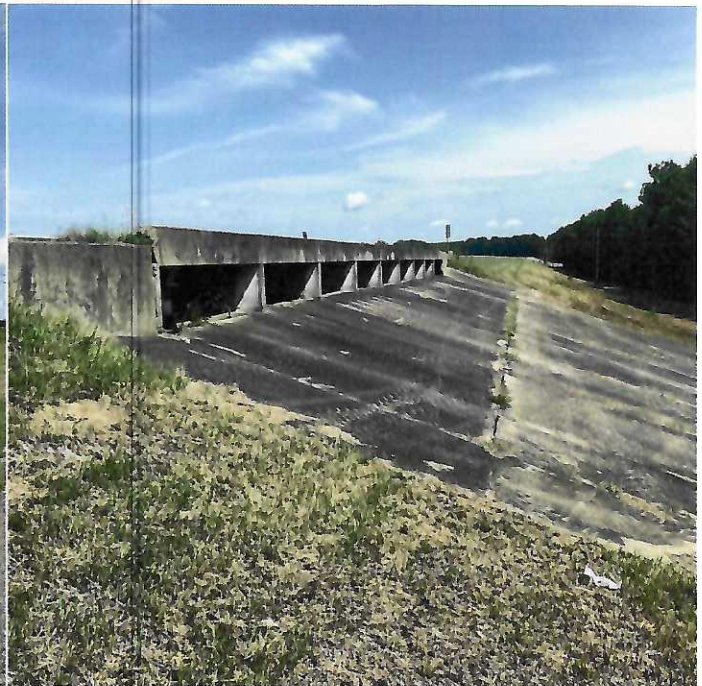
**Condition of spillway cover material:** Concrete in fair condition. Spillway above 100-year discharge elevation.

PHOTO 8—Auxiliary spillway view

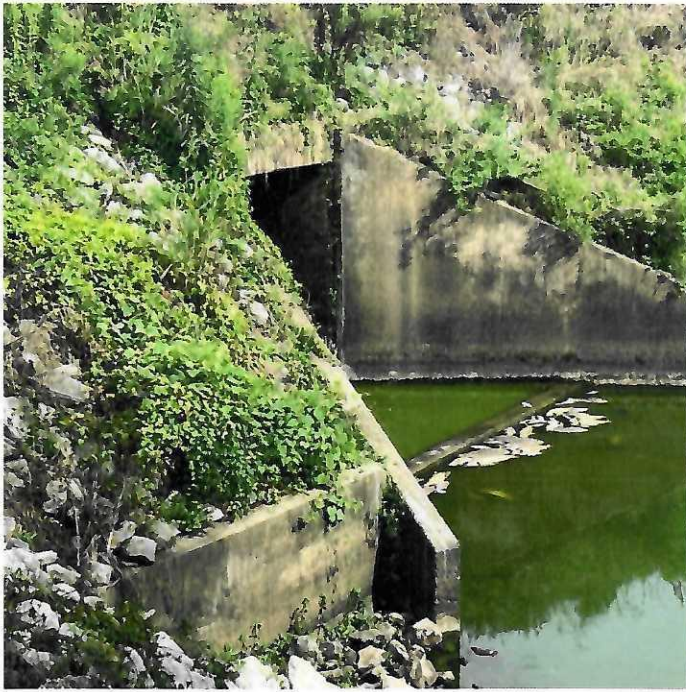
PHOTO 9—Spillway outlet structures from front view

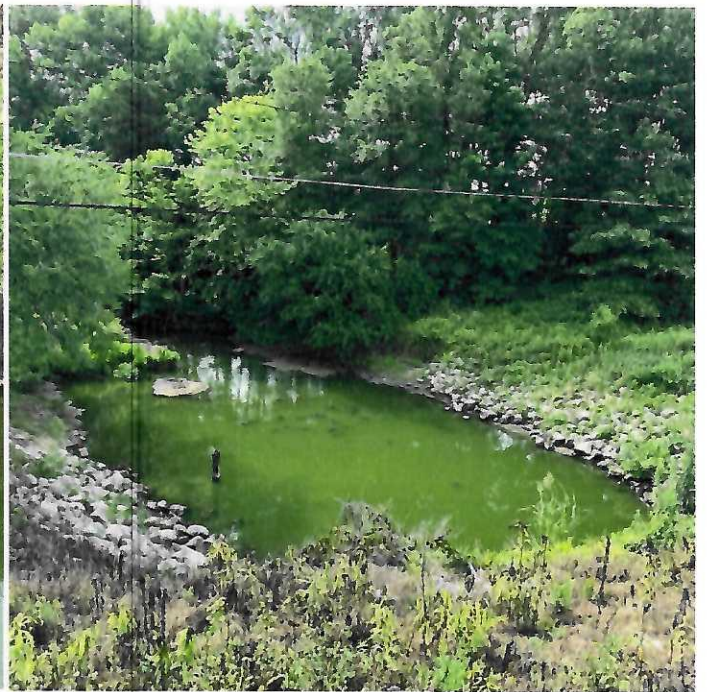
**Exit channel clear of debris / vegetation (Yes / No?):** Channel mostly clear with minimal debris. Some erosion of plunge pool has occurred over the past 50 years.

PHOTO 10—Exit channel view from end of outlet structures

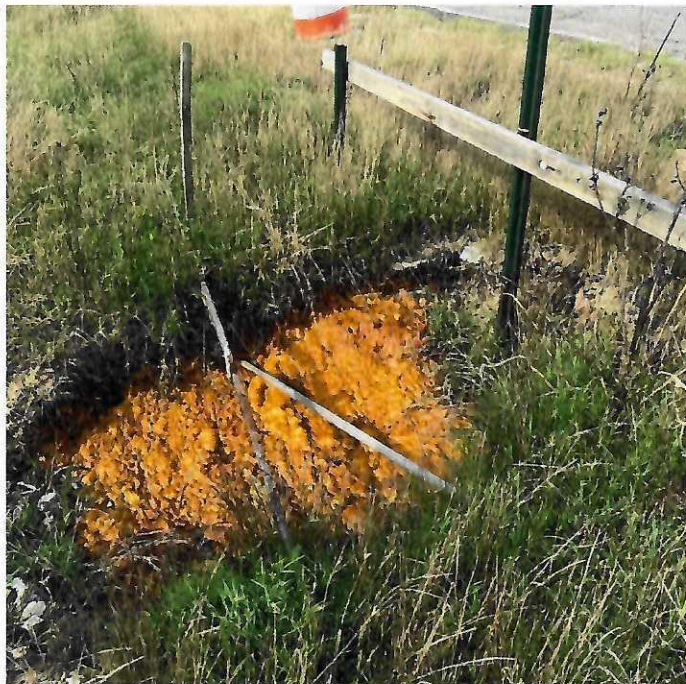
The condition of the surface material was found to be in decent shape. The area above the primary spillway (12'x13' box culvert) had experienced some sinkholes caused by the settlement/shifting of the box culvert, causing gaps in the joints of the box culvert. These gaps had caused some water intrusion/soil loss above the culvert. These gaps have since been repaired with expanding foam that was holding up at time of inspection.

**Condition of structure:** Due to safety concerns, official interior inspection of the riser structure has not been performed. The area above the primary spillway (12'x13' box culvert) had experienced some sinkholes caused by the settlement/shifting of the box culvert, causing gaps in the joints of the box culvert. These gaps had caused some water intrusion/soil loss above the culvert. These gaps have since been repaired with expanding foam that was holding up at time of inspection. Outlet invert and wingwalls appear to be in fair condition.

PHOTO 11 — Area above primary spillway where sinkhole opened caused by joint separation

Continue to closely monitor the 12x13 conduit for joint separation and potential sinkholes.

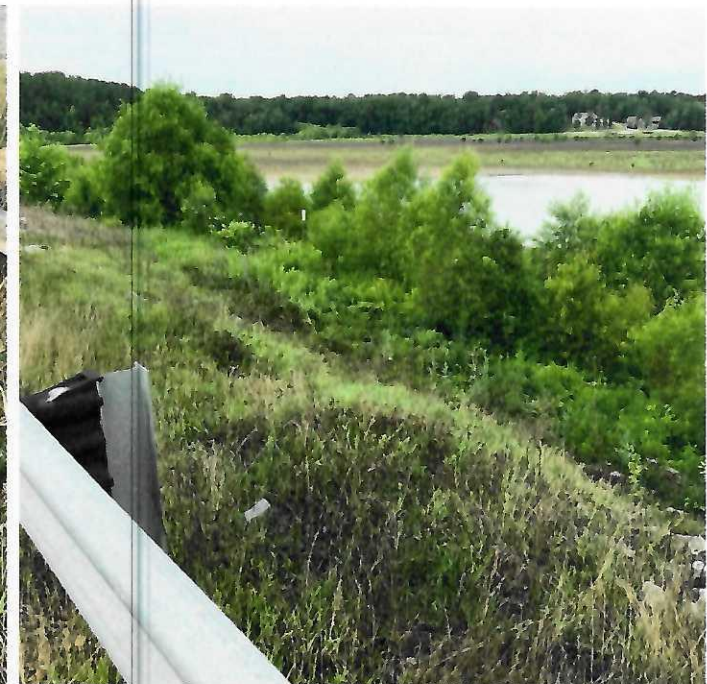
PHOTO 12— Saplings to be removed

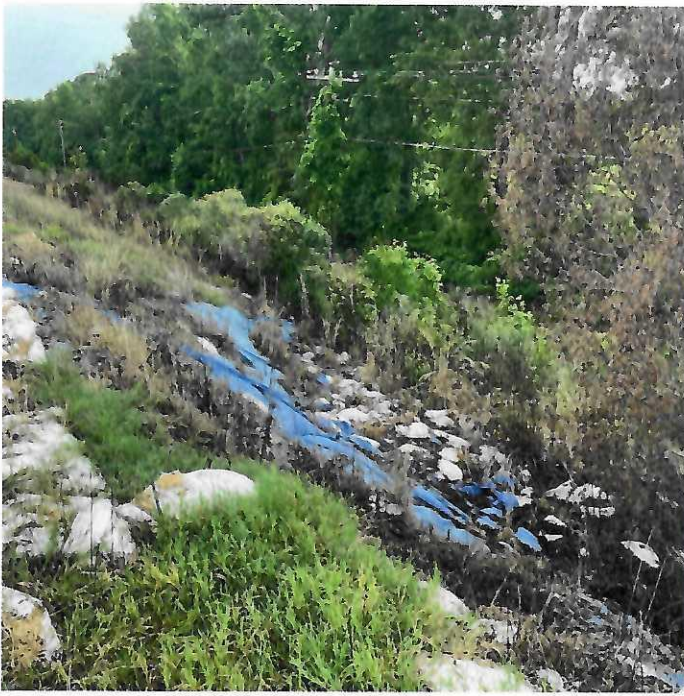
PHOTO 13— Slide area along downstream right embankment

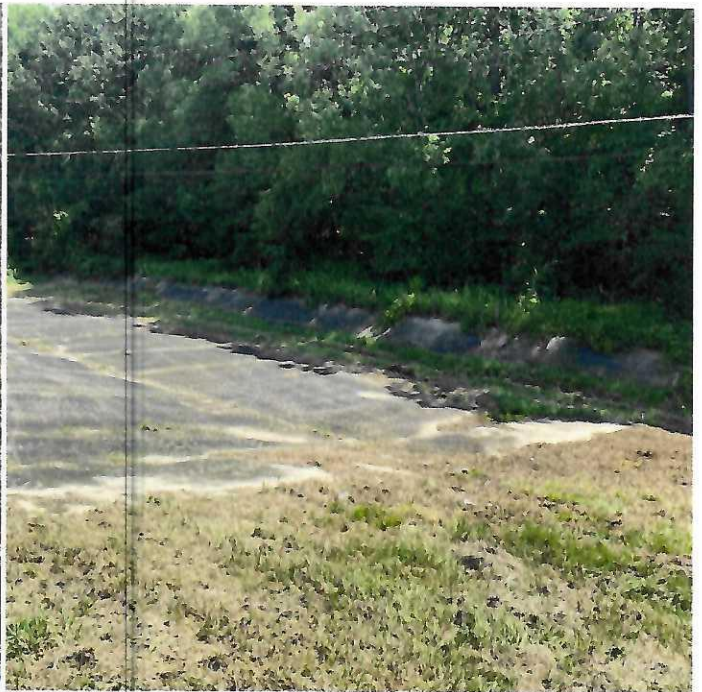
PHOTO 14— Bottom of auxiliary spillway

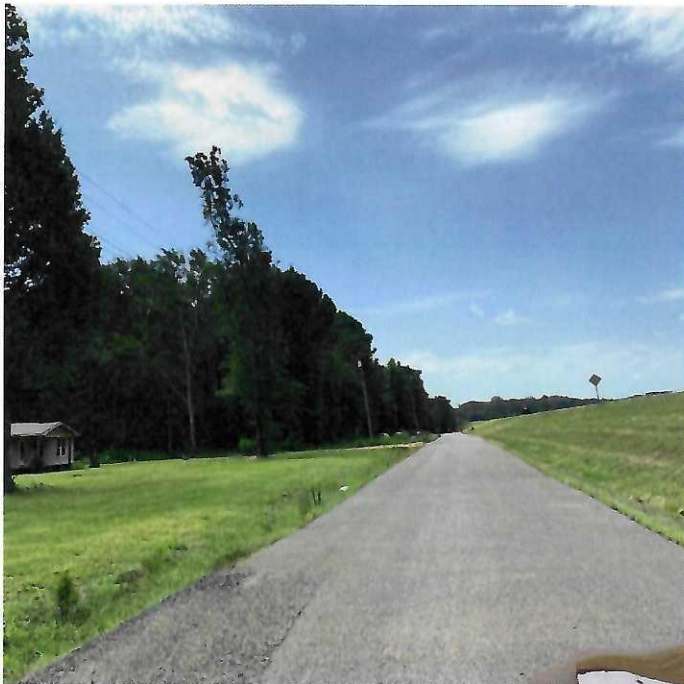
Overhead power lines on poles near toe of downstream dam slope.

PHOTO 15 — Utility lines along Perkins Road

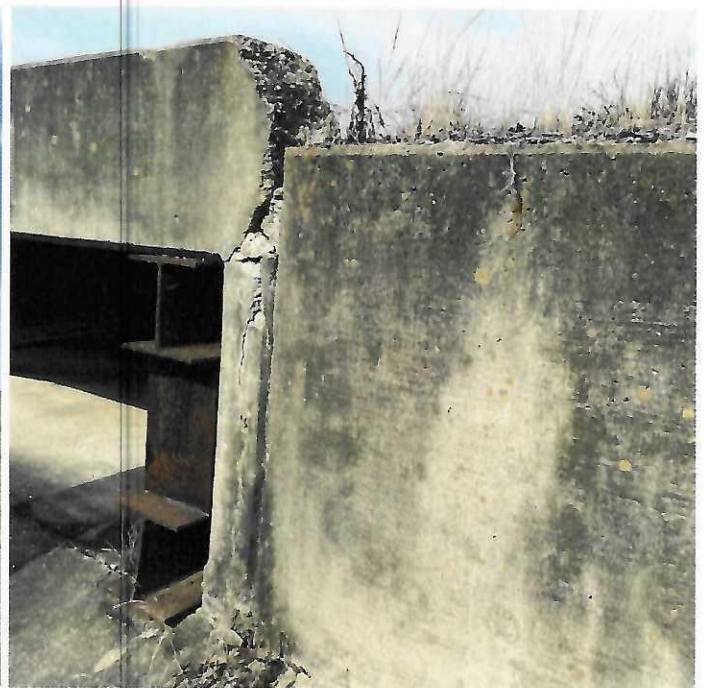
**Erosion present on or below spillway (Yes / No?):** Yes, cracks on north/downstream end

PHOTO 16— Structural damage at downstream left corner of auxiliary spillway
